# **First Five-Year Review Report**

## **Motor Wheel Disposal Site**

**Lansing, Ingham County, Michigan**

**July 2002**

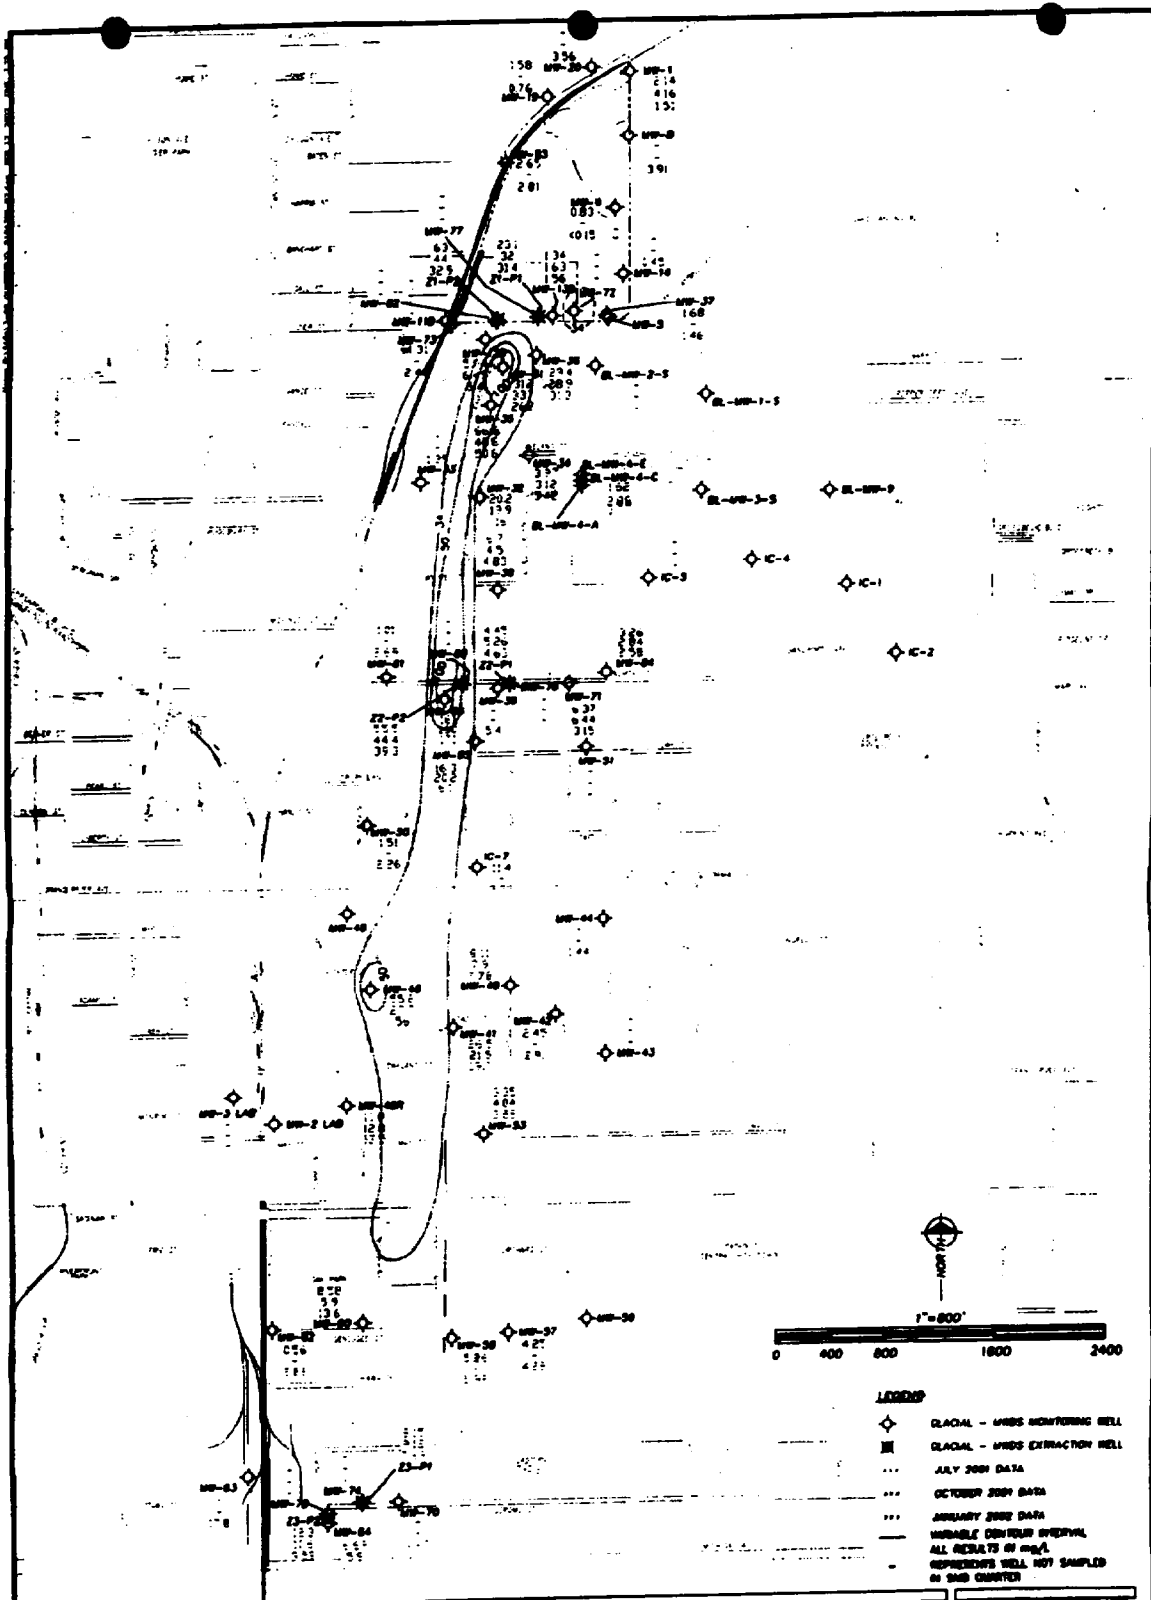
FIGURE 1  
LOCATION MAP  
FOR SAGINAW WELLS DRILLED  
AND TESTED FALL/WINTER 2002

**Figure 1.** The data do not support the lateral spread of the vinyl chloride plume north of the Zone 1 extraction wells as illustrated. It appears appropriate to draw isoconcentration lines north of the pumping wells, but the plume should not "balloon out" as it does as if there were numerous wells with vinyl chloride detections to expand the plume boundaries.

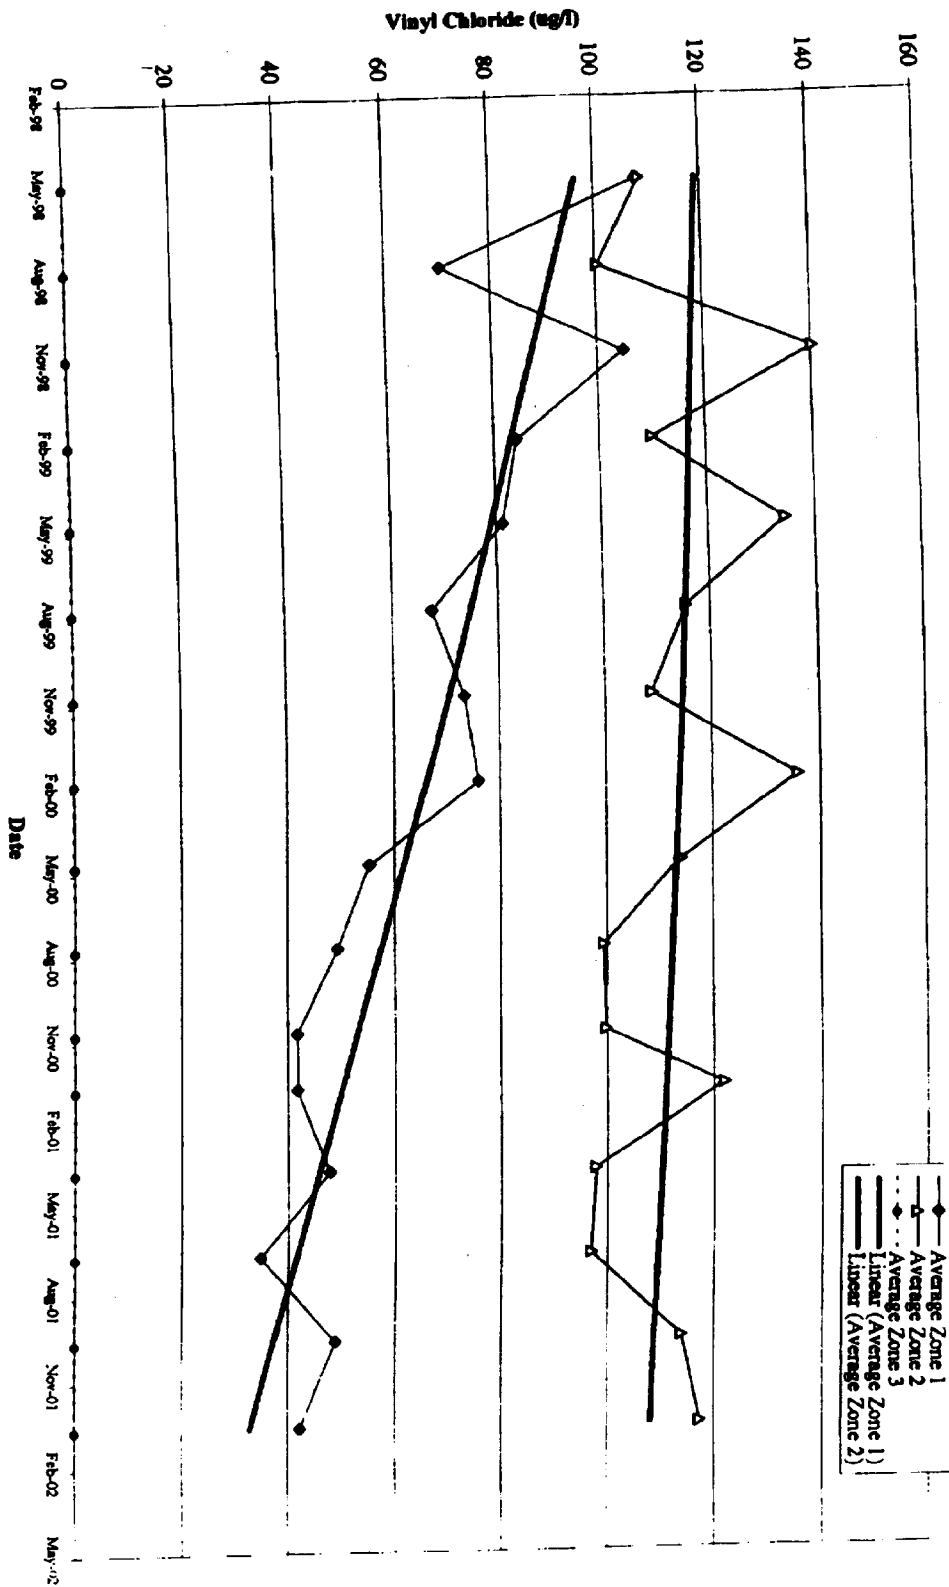
Figure 4 - MWDS Vinyl Chloride Averaged Concentration (By Zone) vs. Time  
April 1998 Through March 2002

First paragraph. The text notes that the vinyl chloride concentrations peaked in April of 1998. However, Figure 4 graphically illustrates these data and May is denoted as the month of peak vinyl chloride concentrations. The text and figure should correlate.

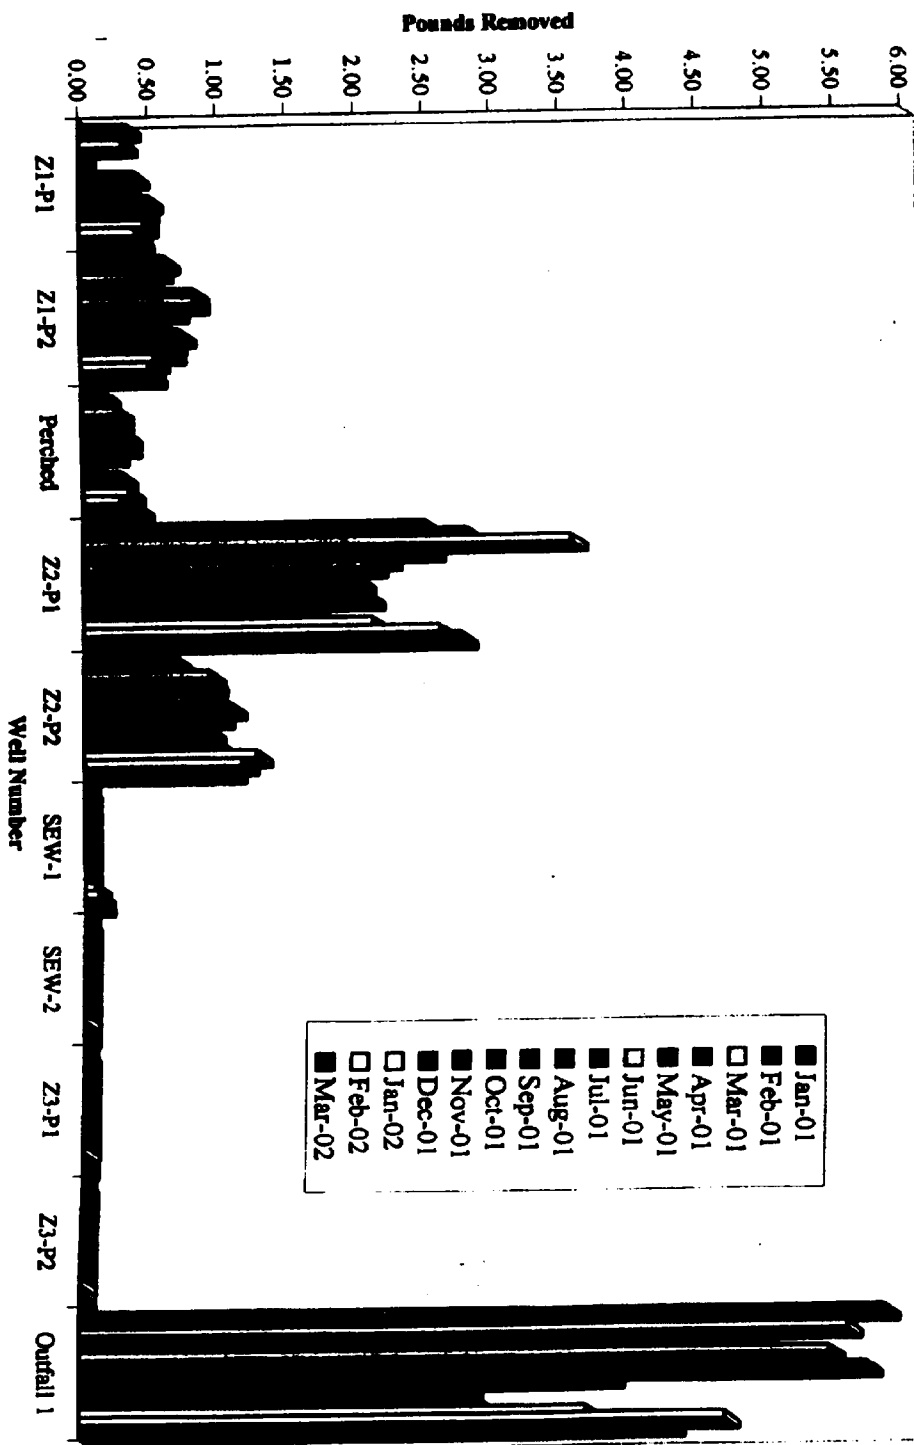
**Figure 9 - MWDS Monthly Vinyl Chloride Mass Removal by Well  
First Quarter 2001 Through First Quarter 2002**

Note: Mass removal by outfall is calculated by the effluent sampling results, so it may not equal the summation of the individual extraction wells. Calculation of results for Z3-P1, Z3-P2, SEW-1 and SEW-2 have been changed to reflect non-detects as zero.

Figure 9. Four of the wells on this figure have never had detections of vinyl chloride in them, yet they are shown to have removed vinyl chloride over the past year, how ever miniscule it might be using the scale on this figure. If nothing has ever been measured in these wells, it is not clear why any concentration of pounds removed should be illustrated in this figure.
